PRELIMINARY NONDESTRUCTIVE EVALUATION MANUAL FOR THE SPACE SHUTTLE

**PRELIMINARY NONDESTRUCTIVE EVALUATION MANUAL
FOR THE SPACE SHUTTLE**

APPENDIX TO FINAL REPORT

**LOCKHEED-GEORGIA COMPANY
A DIVISION OF LOCKHEED AIRCRAFT CORPORATION
MARIETTA, GEORGIA 30063**

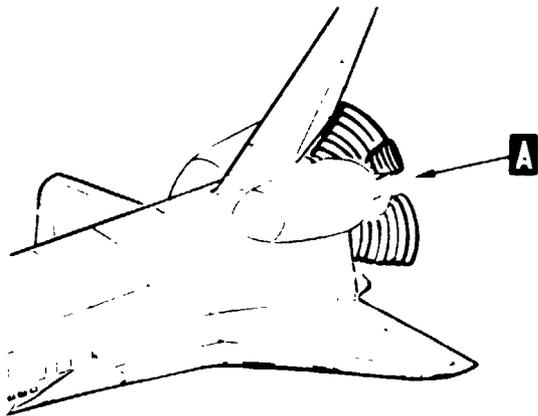
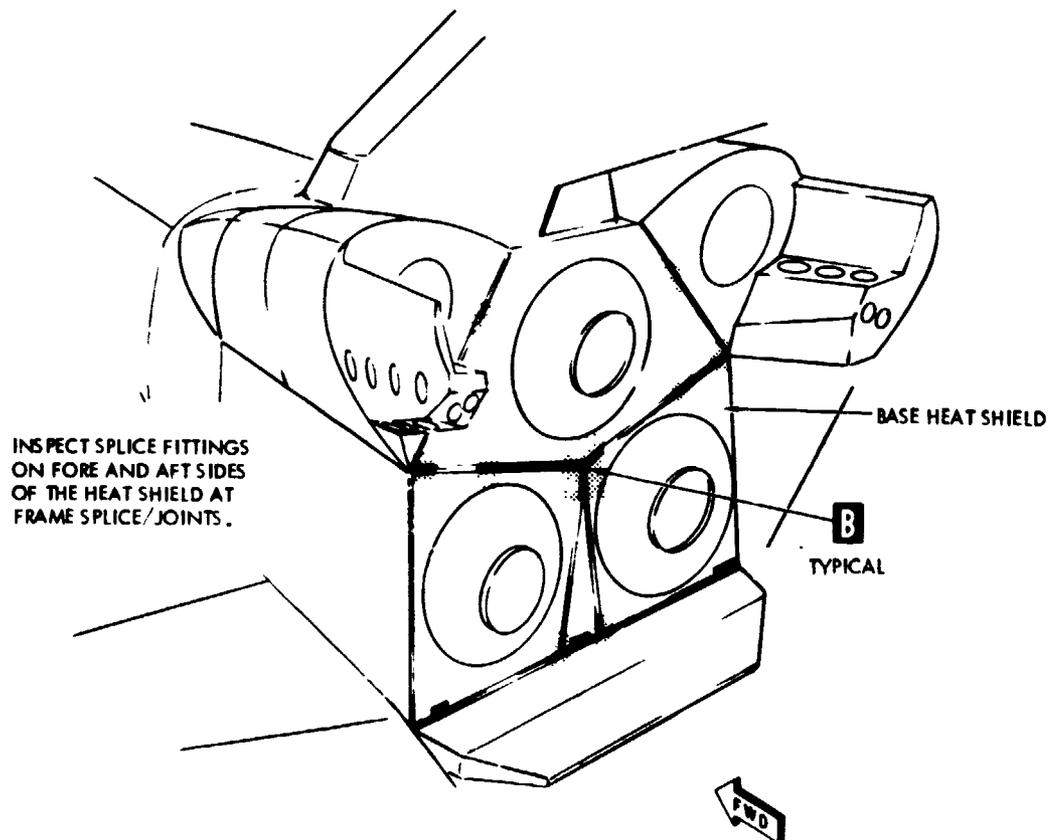
Figure 4-22. Base Heat Shield Framing Structure (Sheet 1 of 2)

DEFECTS: Cracks in the frame intersections, both frame-frame intersections and frame-fuselage intersections.

AFT FUS BASE HEAT SHIELD FRAMING STRUCTURE

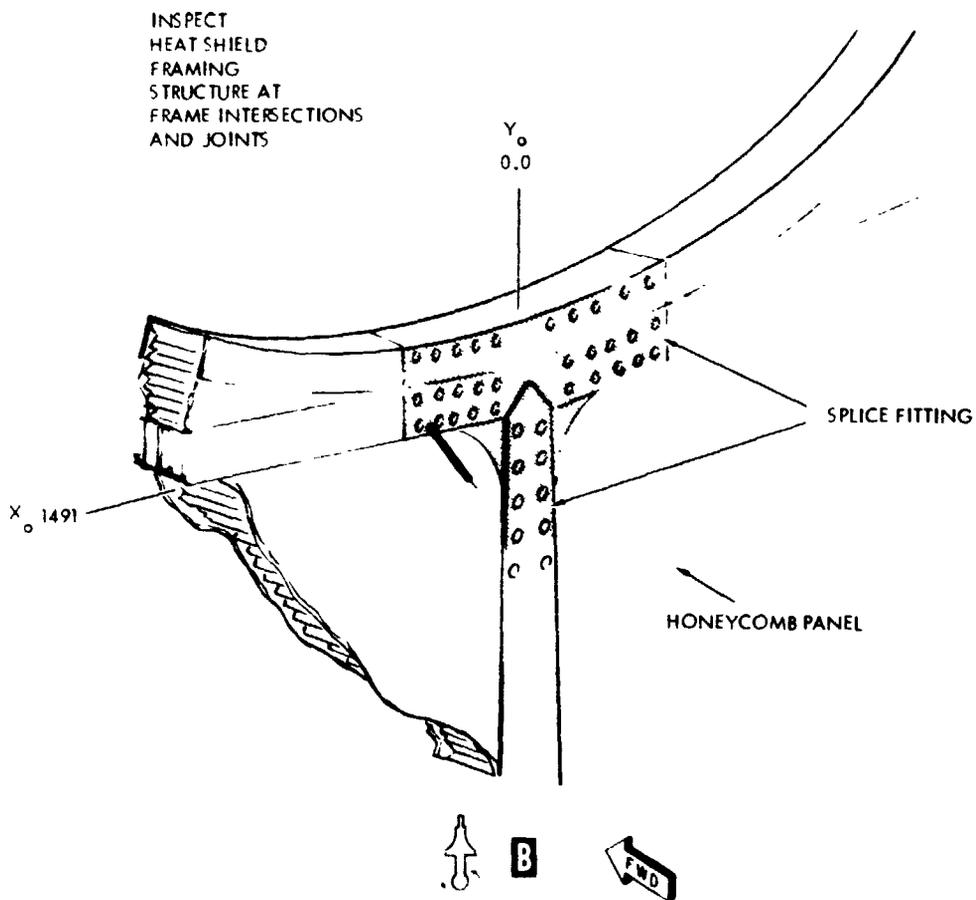
Figure 4-22. Base Heat Shield Framing Structure (Sheet 2 of 2)

HEAT SHIELD CENTRAL FRAME INTERSECTION, TYPICAL.
OTHER INTERSECTION AS INDICATED ON LOCATOR SKETCH.

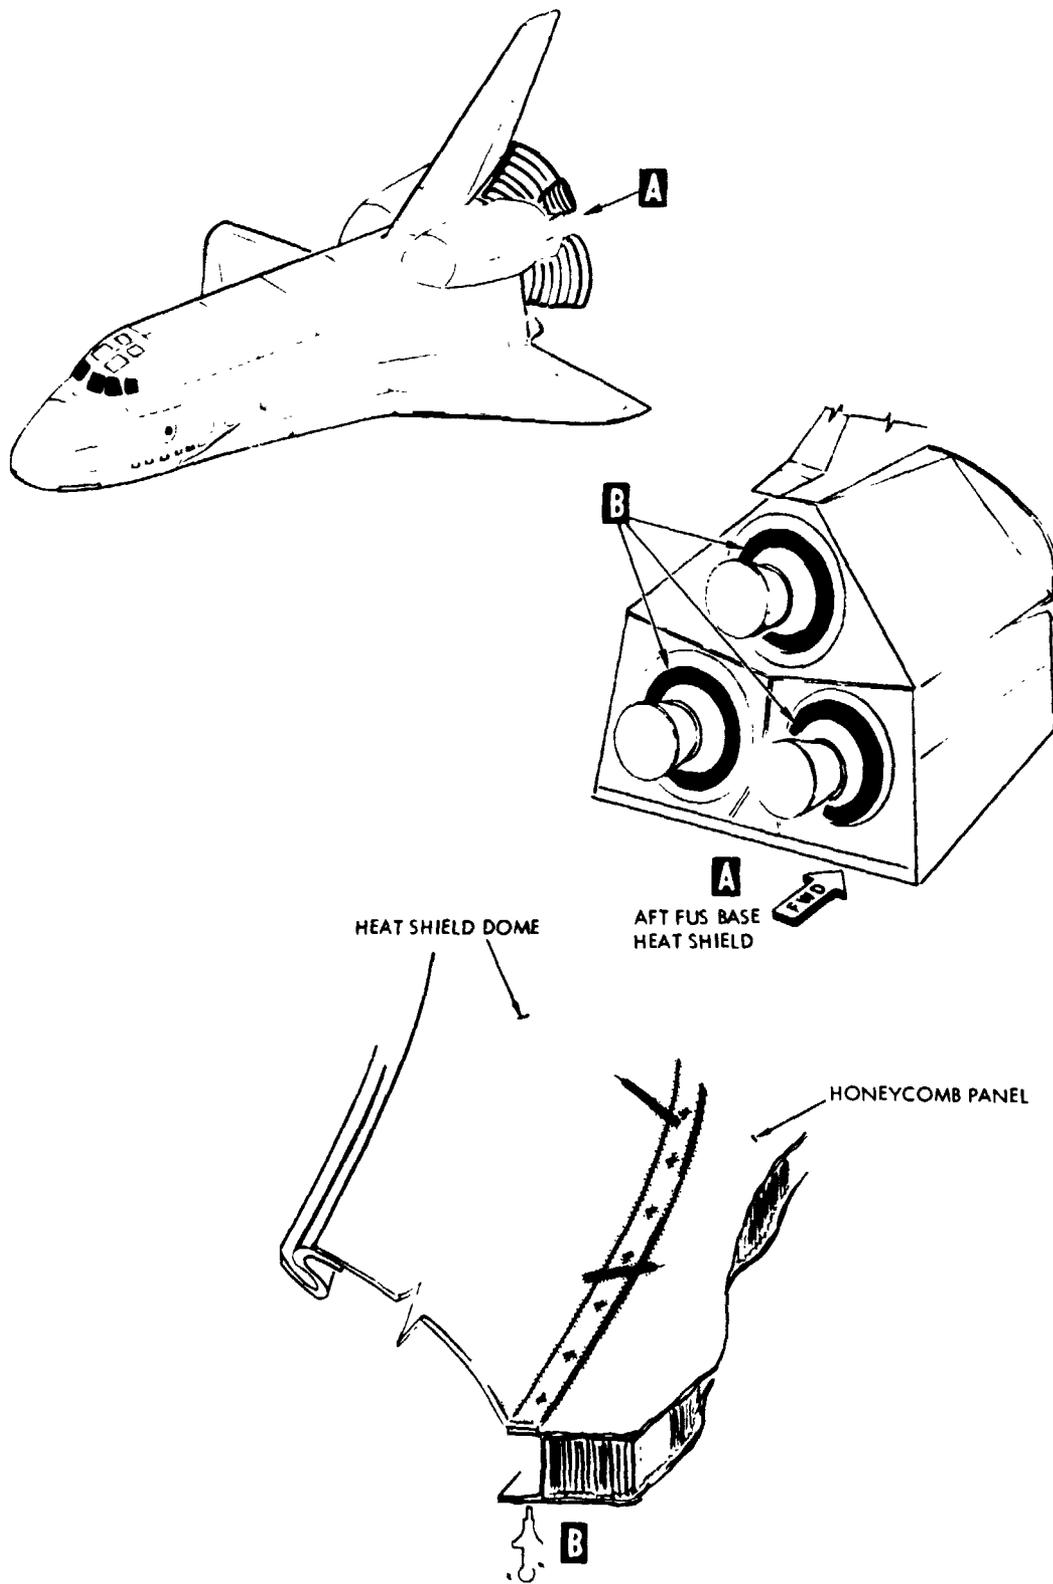
Figure 4-23. Base Heat Shield Dome Structures

The base heat shield domes are inconel alloy annular segments which are attached to the aluminum honeycomb panels and interface with the main engine skirts through an intermediate seal. Atmospheric pressure differentials and extreme vibroacoustic loads during liftoff and ascent may produce damage at the dome attachments to the honeycomb panels.

DEFECTS: Cracks in the dome attachment flange and honeycomb closeout flange.

BASE HEAT SHIELD DOME TO HONEYCOMB ATTACH

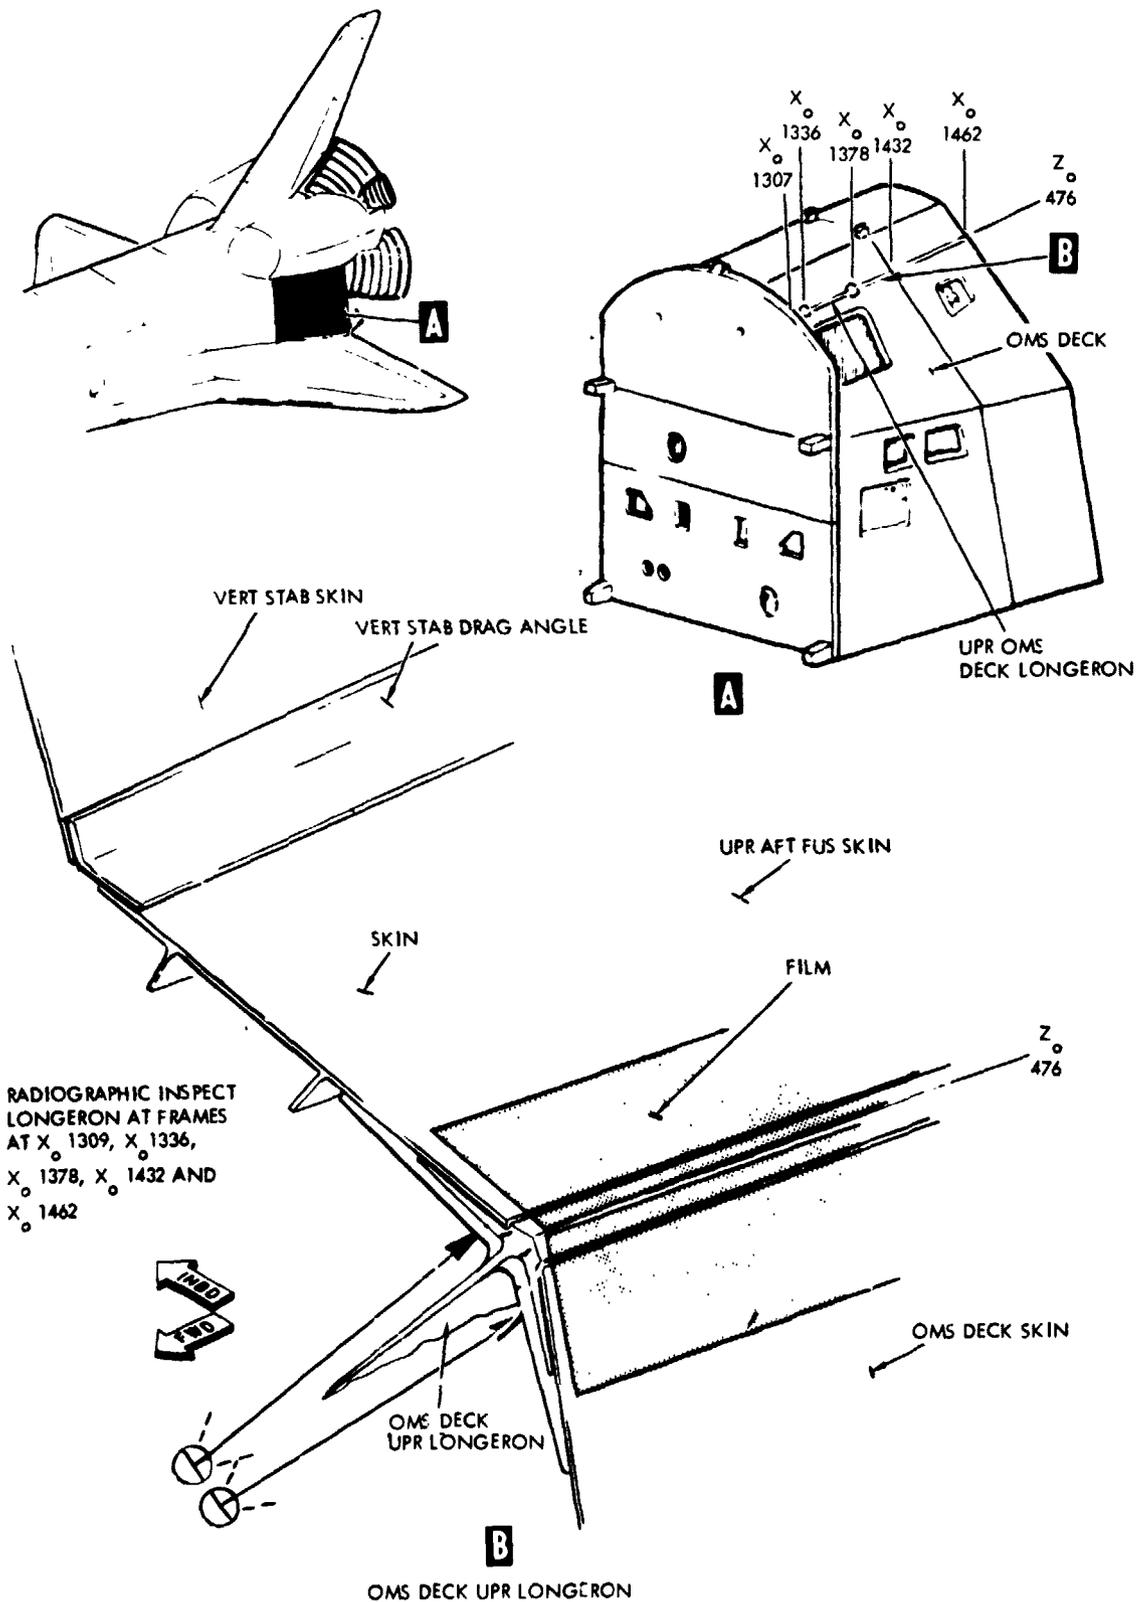
Figure 4-25. Upper Longeron, OMS Deck

DEFECTS: Longitudinal part-through cracks where the inboard and outboard legs join the central body of the longeron near the runout ends of both forward and aft segments.

NDT TECHNIQUES: Primary: Radiographic (para. 1.5.6.2)
Backup: Eddy current (para. 1.5.4.4)

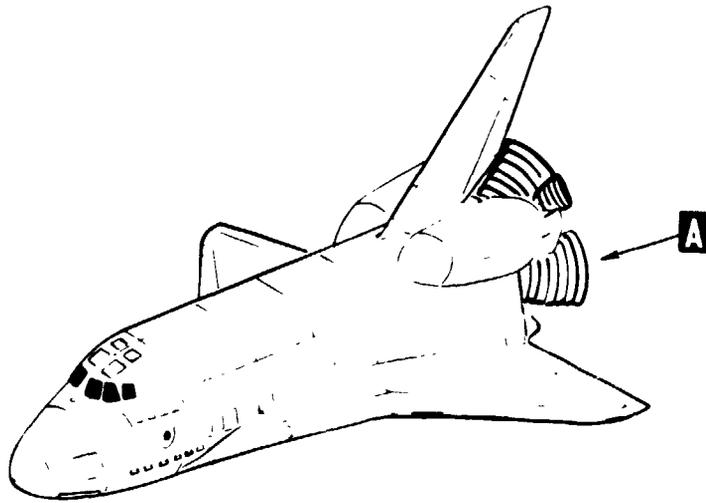
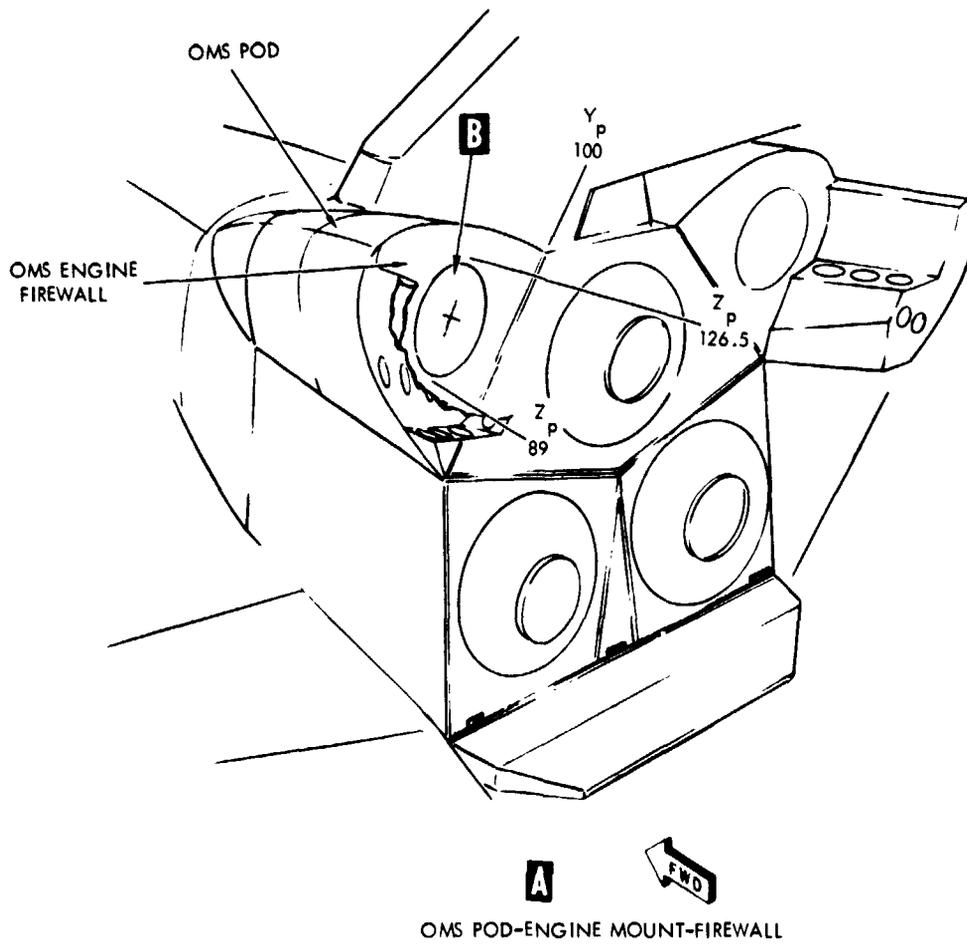
Figure 4-26. OMS Engine Gimbal Actuator Attach (Sheet 1 of 2)

DEFECTS: Radial cracks in the clevis attach lug bolt hole. Cracks in fastener holes in the fitting base-to-pod attach areas.

NDT TECHNIQUES: Primary: Ultrasonic shear wave (para. 1.5.5.3 B) for lug-bolt hole areas and eddy current surface probe (para. 1.5.4.4) for base attachment areas.

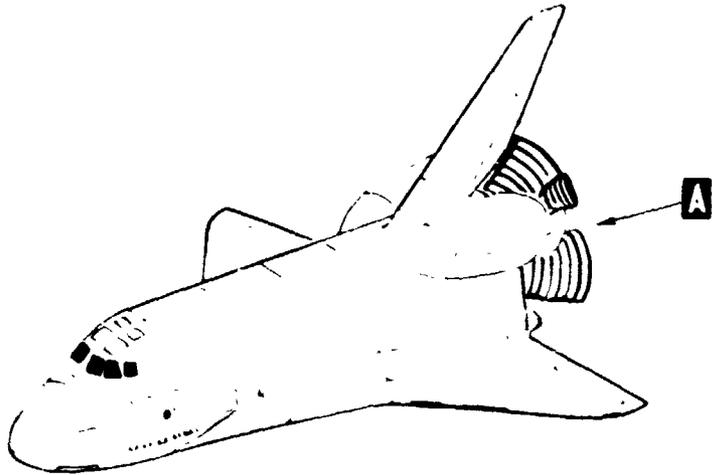
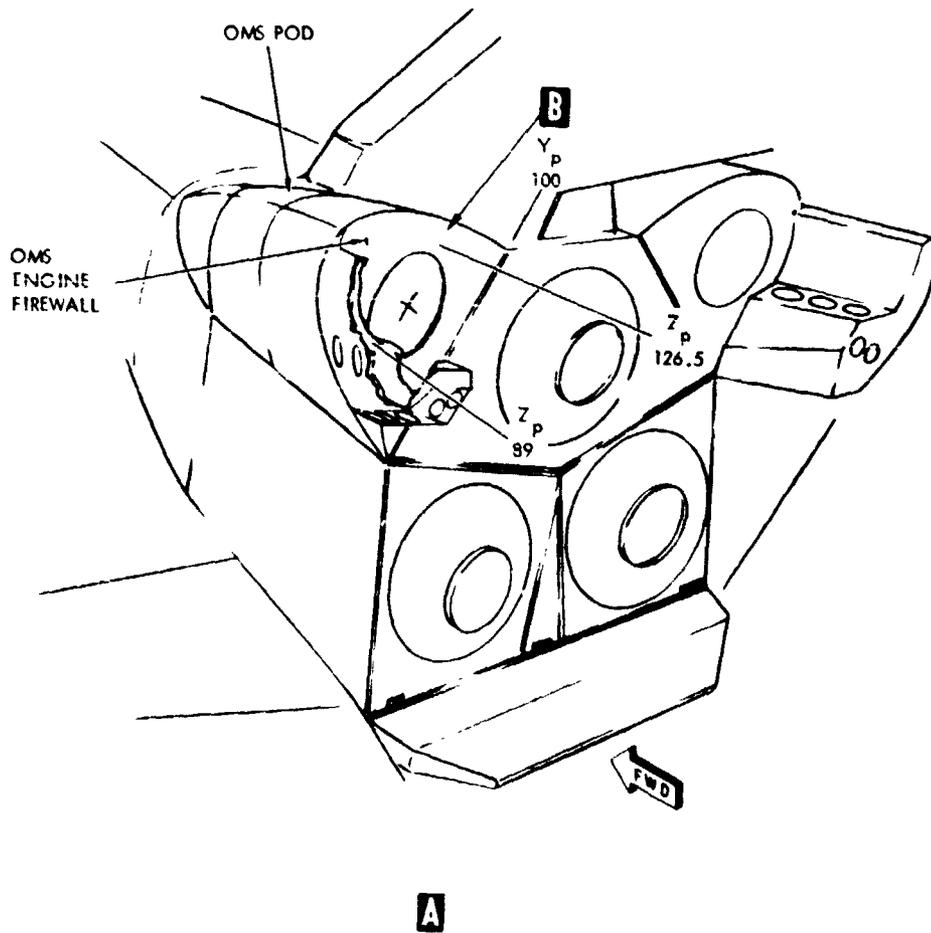
Figure 4-27. OMS Engine Thrust Support Structure (Sheet 1 of 2)

DEFECTS: Fatigue cracks around truss attach clevis lug bolt holes and in the fillet where the lugs blend into their base. Also cracks around fastener holes where the thrust fitting and truss attach fittings mate to the support frames.

NDT TECHNIQUES: Primary: Ultrasonic shear wave (para. 1.5.5.3 B) for the clevis lug bolt holes and eddy current (para. 1.5.4.4) for all other areas.

A
OMS POD - ENGINE MOUNT - FIREWALL

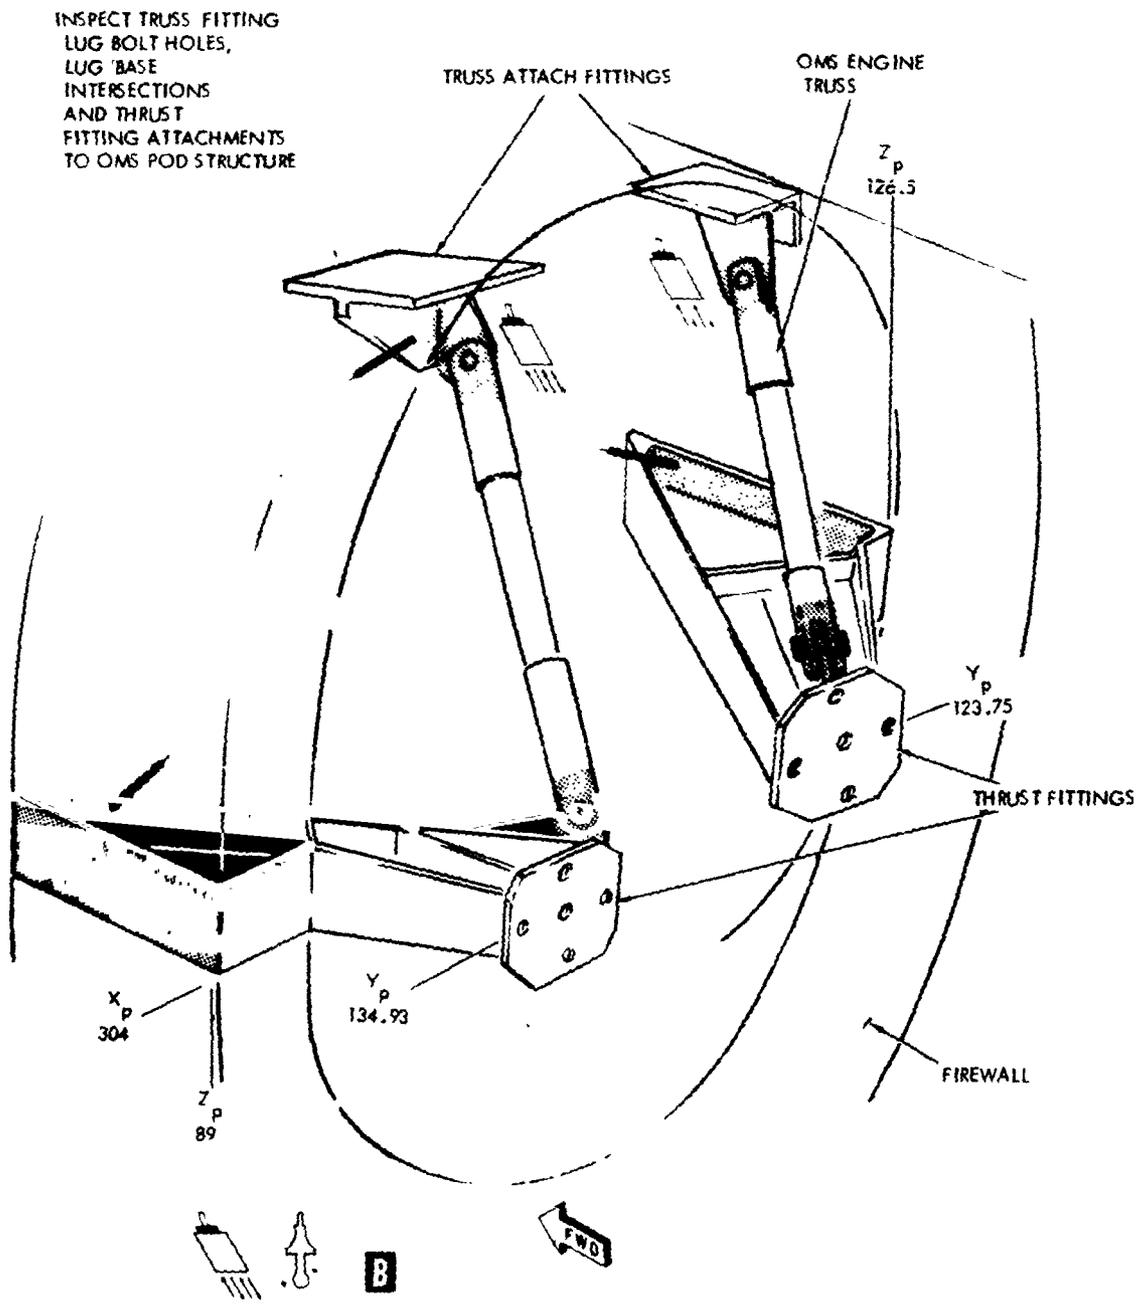
Figure 4-27. OMS Engine Thrust Support Structure (Sheet 2 of 2)

OMS THRUST FITTINGS AND TRUSSES
L.H. SHOWN, R. H. OPPOSITE

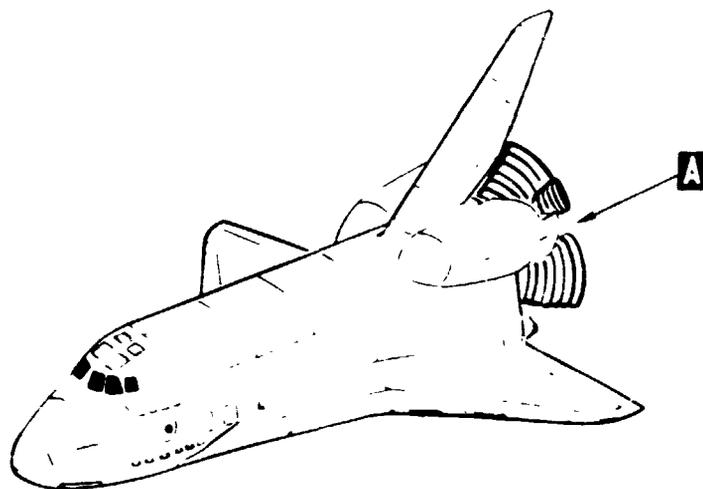
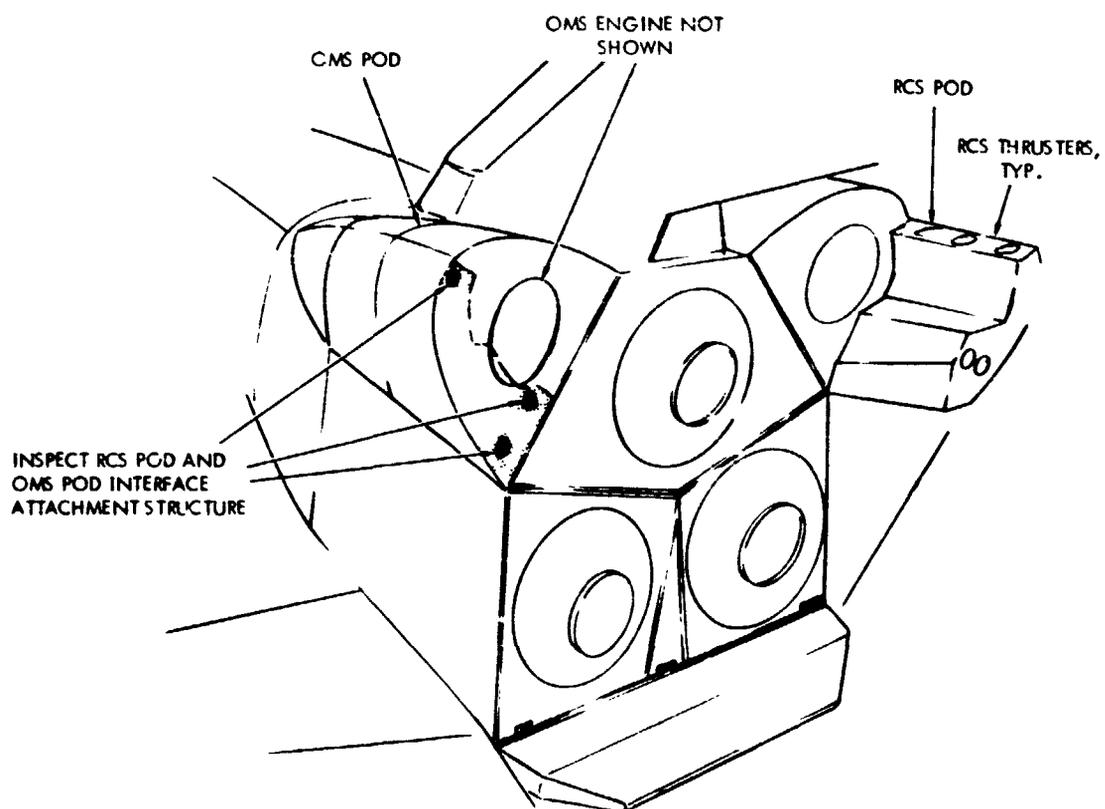
DEFECTS: Cracks in the OMS pod/RCS pod attachment areas, particularly around the attachment bolt.

NDT TECHNIQUES: Primary: Ultrasonic shear wave (para. 1.5.5.3 C) and eddy current surface probe (para. 1.5.4.4)

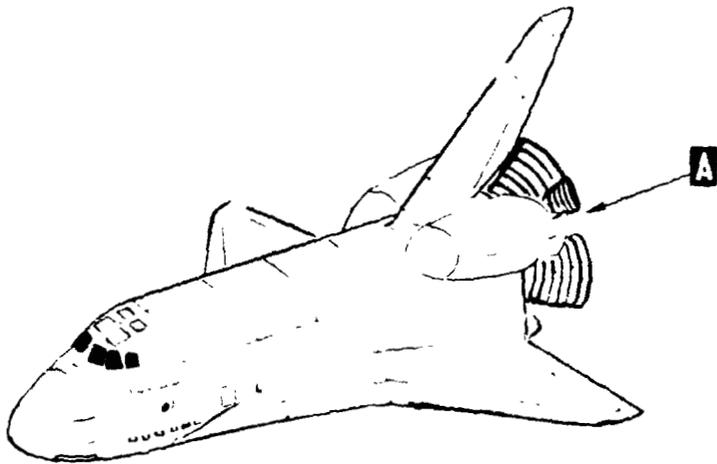
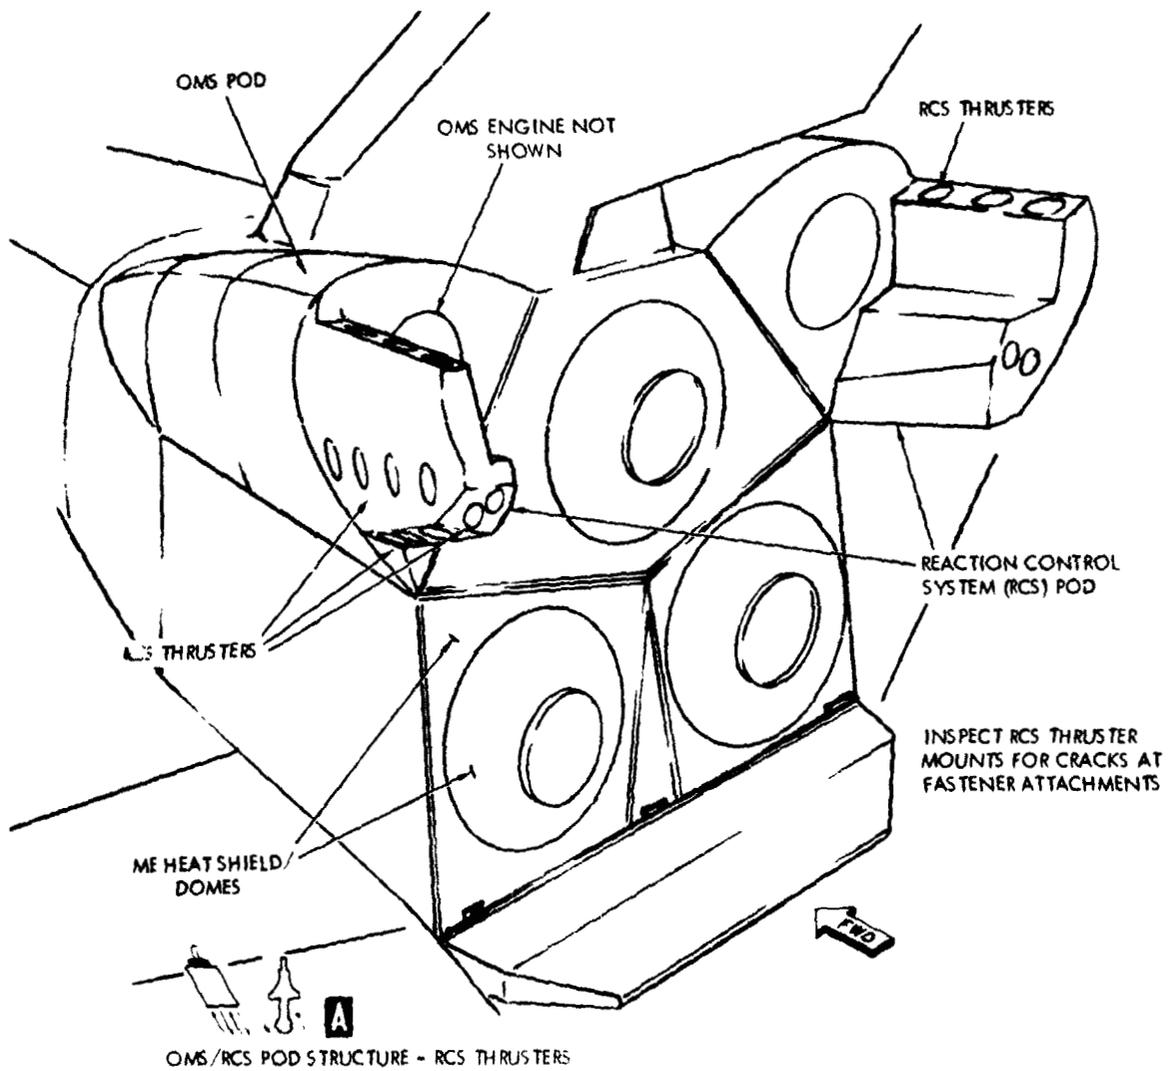
Figure 4-29. Aft RCS Engine Mounts

DEFECTS: Cracks in the engine mount attachment holes.

NDT TECHNIQUES: Primary: Ultrasonic shear wave (para. 1.5.5.3 C) or eddy current surface probe (para. 1.5.4.4)

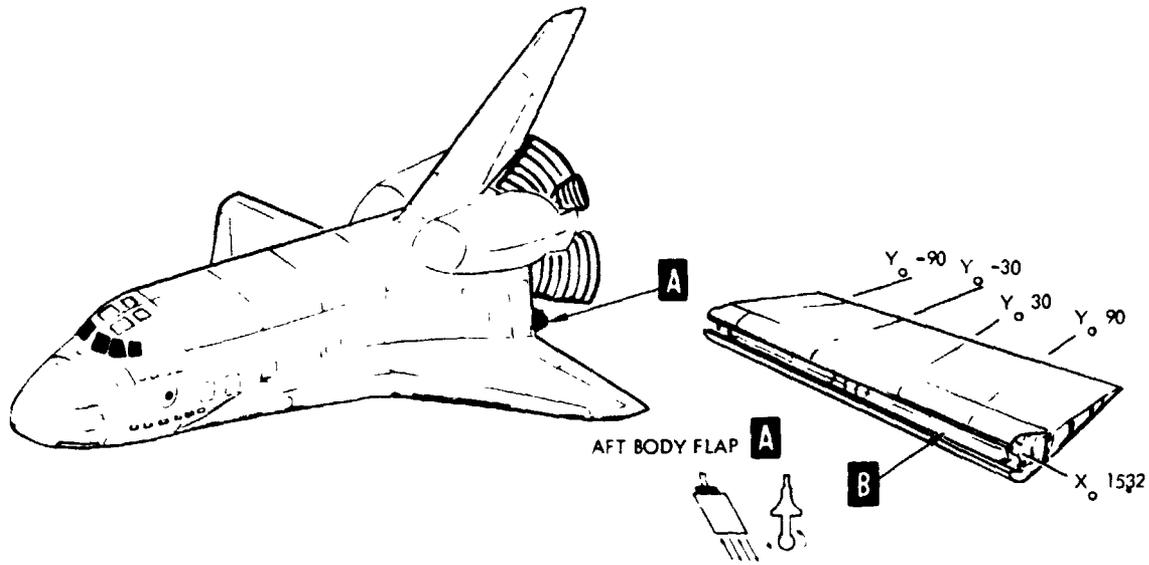
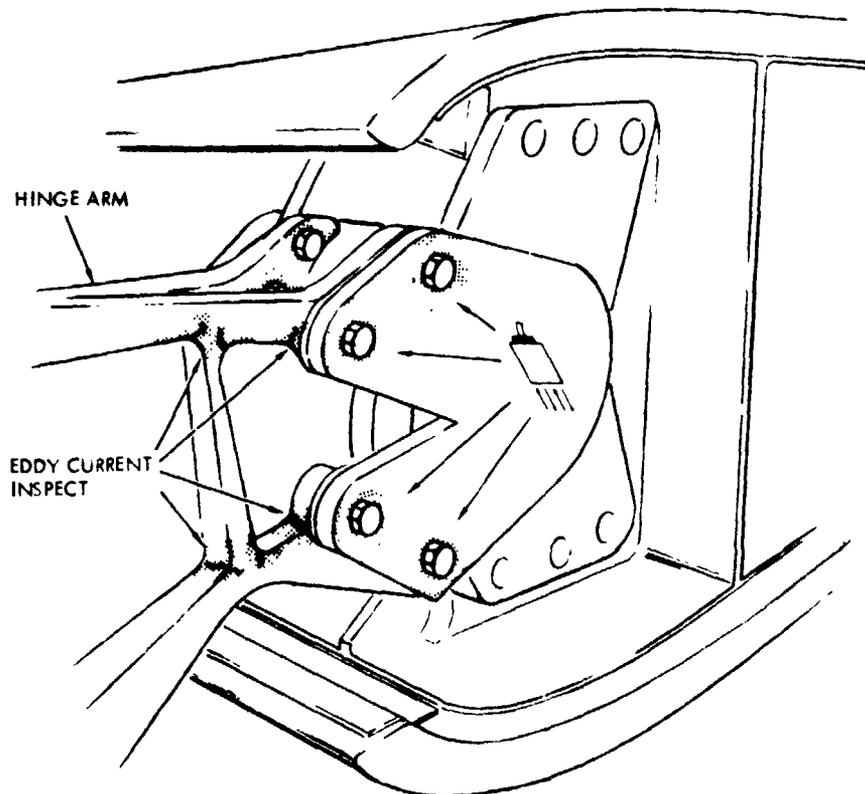
Figure 4-30. Aft Body Flap Hinges

COMPONENT/AREA DESCRIPTION: AFT BODY FLAP HINGES. The aft body flap is used to protect the main engine skirts and to provide a movable control surface for vehicle trim during entry. It is actuated at four locations by power hinges at $Y_{\circ} \pm 30$ and $Y_{\circ} \pm 90$ along the X_{\circ} 1532 hinge line. The power hinges are attached to the body flap front spar and the lower aft-fuselage heat shield support frame. Aerodynamic loads during entry and atmospheric flight and high vibro-acoustic loads at lift-off may cause damage to the hinges. The hinges are made of titanium (-6Al-4V) alloy.

DEFECTS: Radial cracks at hinge assembly bolt holes and at hinge attachment arms.

NDT TECHNIQUES: Primary: Ultrasonic shear wave (para. 1.5.5.3 B & C) for bolt holes; ultrasonic surface wave (para. 1.5.5.1) for attachment arms (if hinge is made of uncoated titanium) or eddy current surface probe (para. 1.5.4.4).

ULTRASONIC INSPECT
AROUND BOLT HOLES
IN HINGE FITTINGS
AND HINGE ARM

B AFT BODY FLAP
HINGE FITTINGS,
TYPICAL 4 PLACES

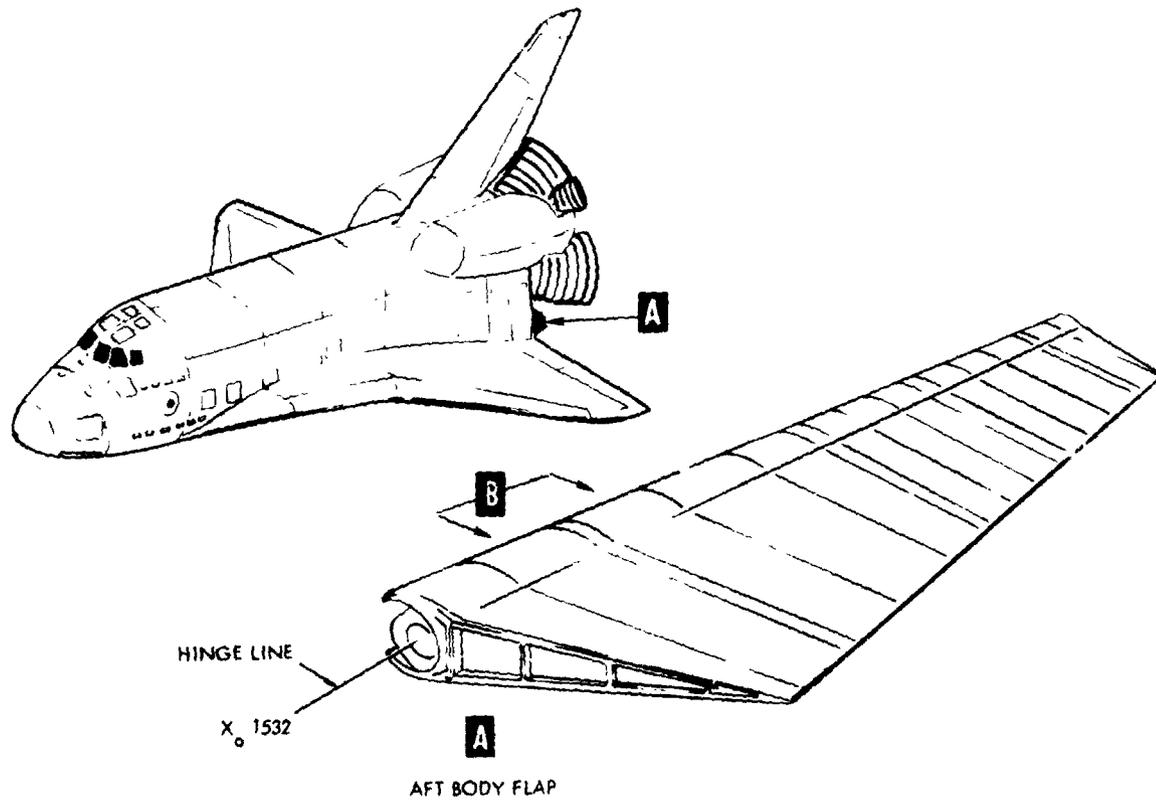
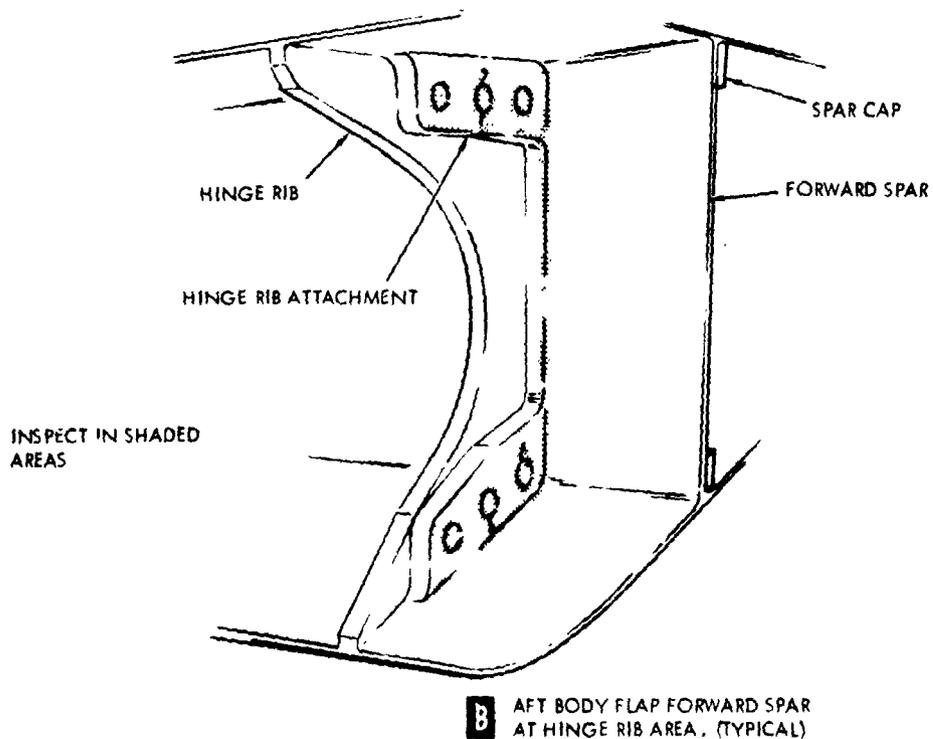
Figure 4-32. Aft Body Flap Front Spar

The front spar is made of 2024-T86 aluminum alloy and contains a zinc chromate primer and Supercorapon 515-700 paint surface finish. The body flap power hinges transfer loads into the front spar because of vibroacoustic loads and reactions to aerodynamic loads. The areas of the front spar in the vicinity of the hinges should be inspected for fatigue damage.

DEFECTS: Edge through-cracks in the spar caps and webs in the vicinity of body flap hinge attachments to hinge ribs.

NDT TECHNIQUES: Primary: Eddy current surface probe (para. 1.5.4.4)
Backup: Fluorescent penetrant (para. 1.5.2.1 Fig. 1-9)

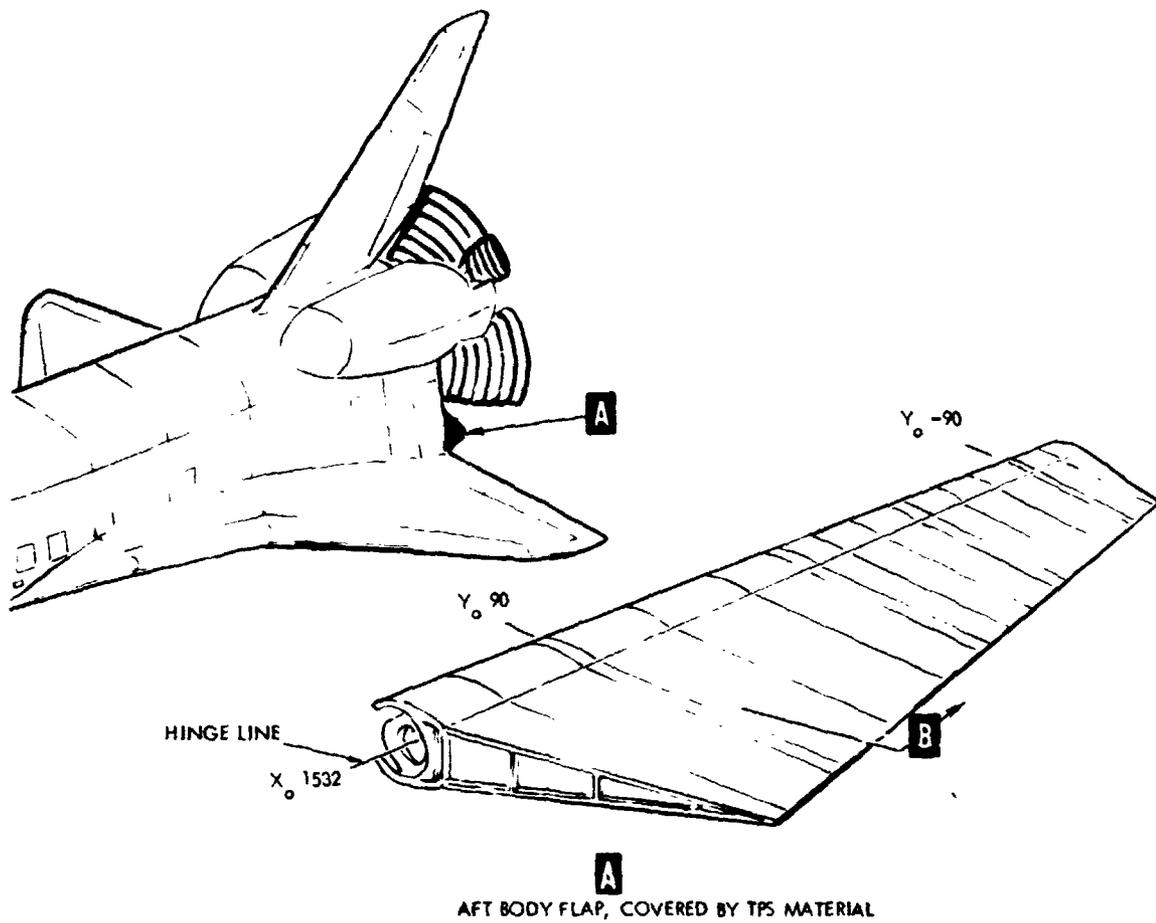
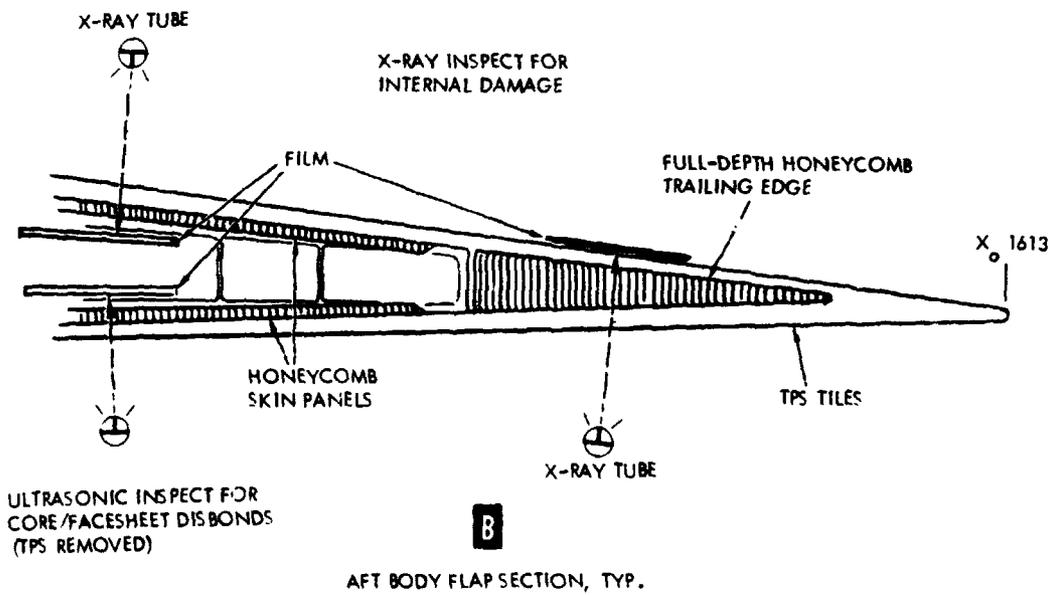
Figure 4-33. Aft Body Flap Honeycomb Skin Panels

The flap is used to protect the main engine skirts and to provide a movable control surface for vehicle trim during entry. The assembly is subjected to vibroacoustic, aerodynamic and thermomechanical loads which may cause face sheet to core disbands or core separations near the bondline. Core damage due to ice or corrosion caused by internal residual reactive gases and moisture can also occur with time and repeated mission cycles. Core damage on lower surface may be caused by impact of runway debris.

DEFECTS: Inspect for core-to-facesheet or near-bondline disbands and separations, entrapped water, and core damage corrosion (crushed core and corrosion).

NDT TECHNIQUES: Backup: For disbond verification, use a mechanical pull test on local suspect area. Core damage can be verified by ultrasonic or sonic (para. 1.5.5.6) thru-transmission techniques.

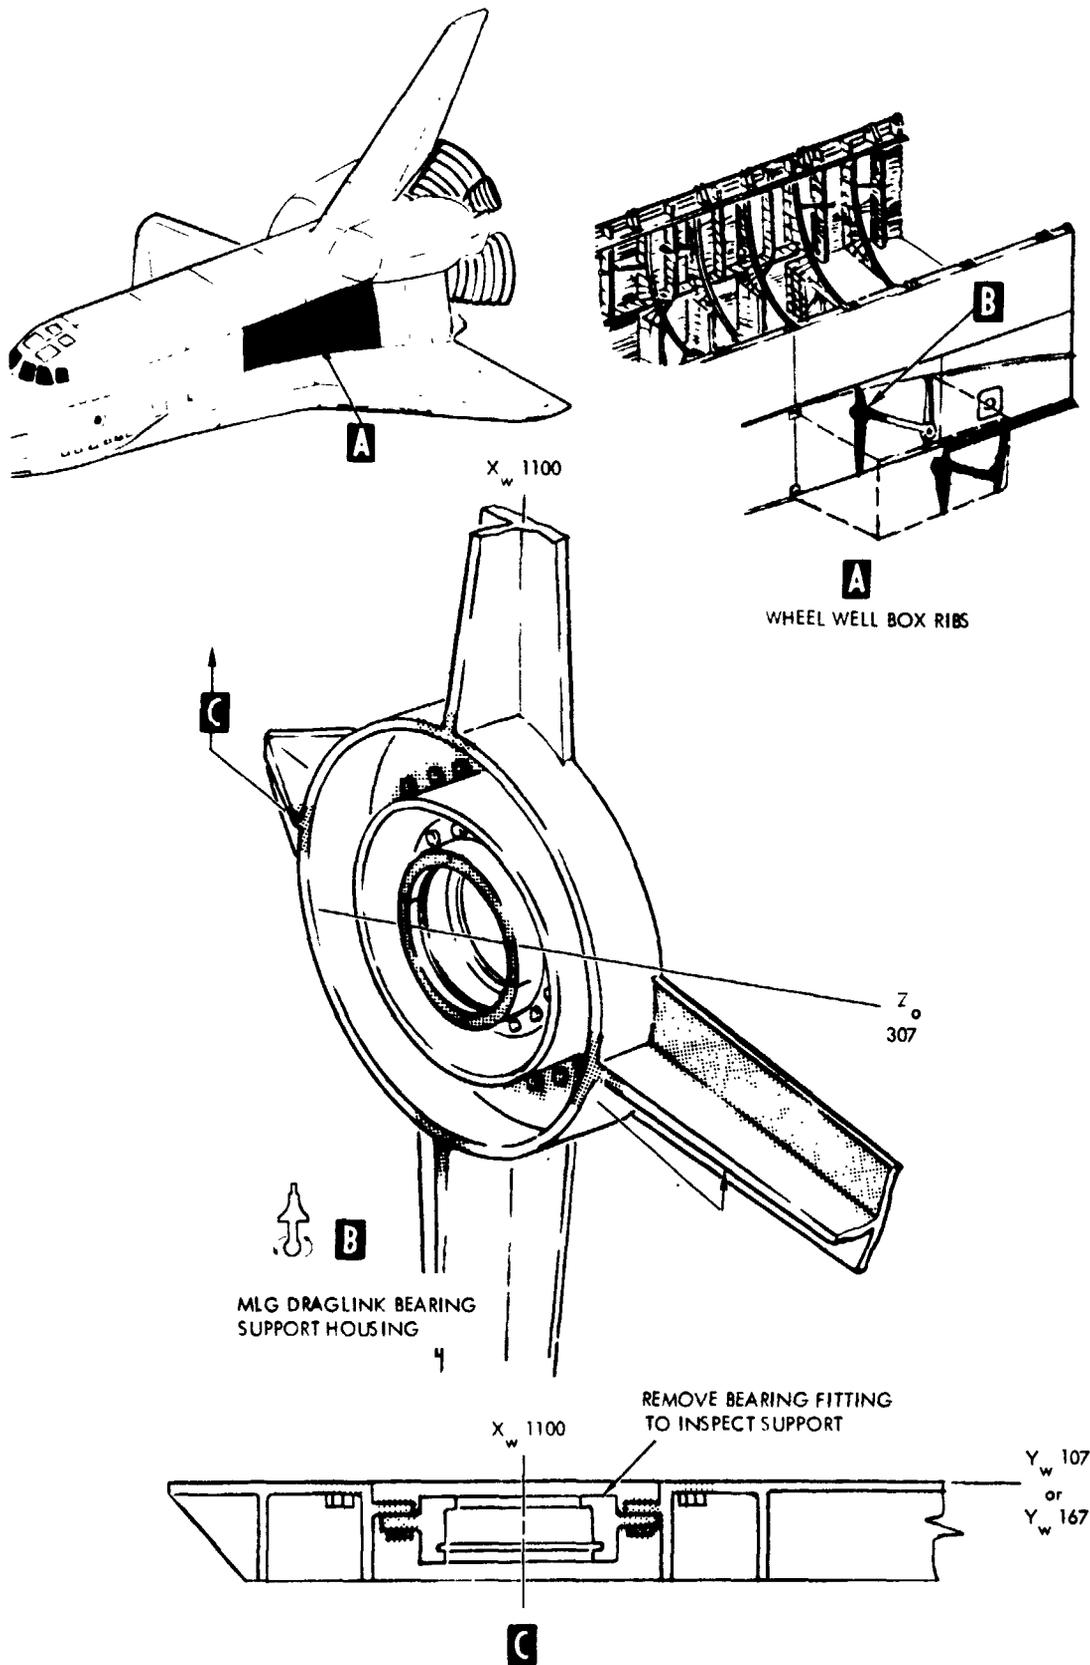
Figure 5-1. MLG Drag Link Support

NDT TECHNIQUES: Primary: Ultrasonic shear wave (para. 1.5.5.3 B & C) for bearing hole inspection, eddy current (para. 1.5.4.4) for fillet areas and bootstrap fittings.

Backup: Eddy current bolt hole (para. 1.5.4.3) for bolt holes and fluorescent penetrant (para. 1.5.2.1 Fig. 1-9) for other areas.

PROCEDURE NO. 5-601, Figure 5-1

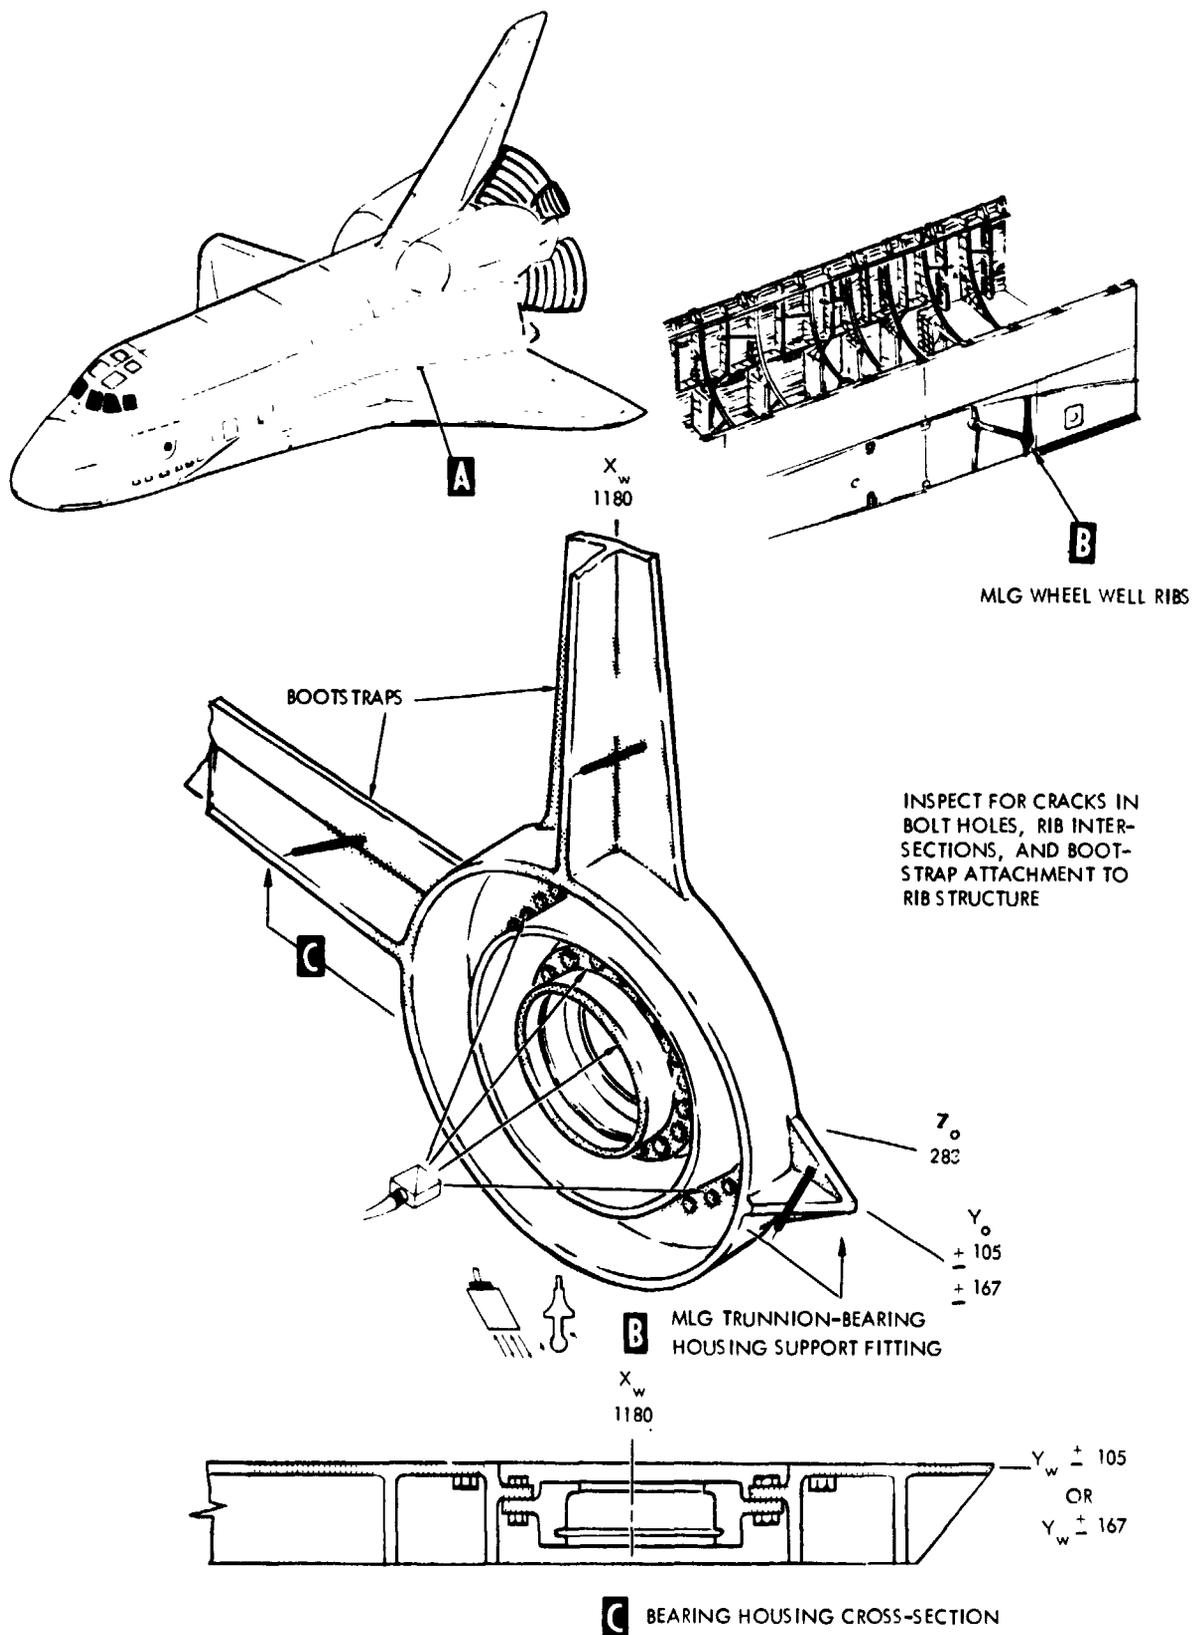
Figure 5-2. MLG Trunnion Support Fitting

DEFECTS: Hard landings and taxi conditions may produce radial fatigue cracks at the bearing housing bolt-hole and fillets in the bearing housing and in the bearing housing support fitting; cracks at attachment holes in the boot-strap fitting.

NDT TECHNIQUES: Primary: Ultrasonic shear wave (para. 1.5.5.3 B & C) for bolt holes, eddy current (para. 1.5.4.4) for fillet areas and bootstrap fitting.

Backup: Eddy current bolt-hole (para. 1.5.4.3) for bolt-holes
fluorescent penetrant (para. 1.5.2.1 Fig. 1-9) for fillets and other areas.

PROCEDURE NO. 5-602, Figure 5-2
